## Failure analysis of stainless steel lanyard wire rope

A. Sambasiva Rao

A. K. Singh\*

*Defence Metallurgical Research Laboratory, Kanchanbagh, Hyderabad, 5000258, India*

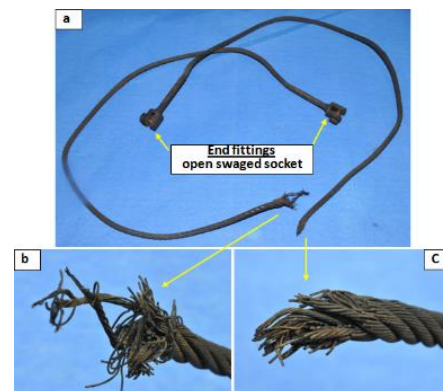
The broken wire rope in as-received condition is shown in Figure 1(a-c). This displays dark brownish colour. The wire rope supplied with two broken ends (Figure 1a). This consists of many small diameter wires wound together into strands and then these strands are knit jointly into a wire rope. The end fittings of the wire rope are fastened with open swaged socket. Broken end region displays several wires unwound and loosen from their strands (Figure 1b and c). Chemical composition of the wire rope indicates that the wires are made using austenitic stainless steel AISI 304 grade (Table 1).

Fig. 1. Photograph of failed wire rope: (a) as-received condition, (b) one end of the broken rope, (c) another end of the broken rope displays several wires unwound from its strands and loosens from their strands.

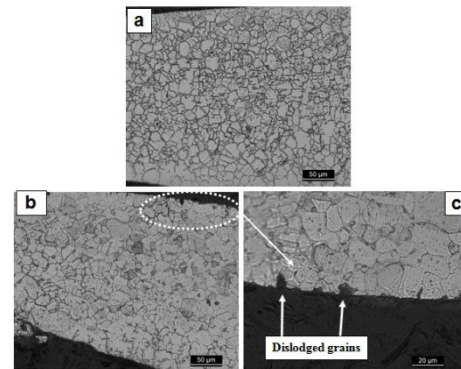
Optical microstructures of failed wire rope are shown in Figure 2. This displays the presence of typical equiaxed austenitic grains along with annealing twins (Figure 2a). The average grain size is ~ 15  $\mu$ m (ASTM No. 8.5). The grain size near and away from failed region appears to be same. The optical microstructure of the wire exhibits two

features namely (a) overall grain size is nearly uniform from center to periphery and (b) several cracks along the grain boundaries at the periphery of the wire rope (Figure 2b and c). Presence of annealing twins within the equiaxed austenitic grains indicates that the wire rope is used in annealed condition (Figure 1, 2a). This also suggests that the rope wires are initially prepared by wire drawing and subsequently annealed. In addition, several grains have been dislodged from periphery of the individual broken wire (Figure 2b and c). The dislodged materials have broken and separated from the wire along the grain boundaries. This clearly reveals that the grain boundaries have significantly weakened during service. Very close to the fractured area, the microstructure exhibits extensive material degradation due to grain boundary weakening.

Fig. 2. Optical micrograph of failed wire rope shows (a) austenitic grain structure with annealing twins, (b) few grains are dislodged from the grain boundaries at the surface near fracture and (c) high magnification of dislodged grains.

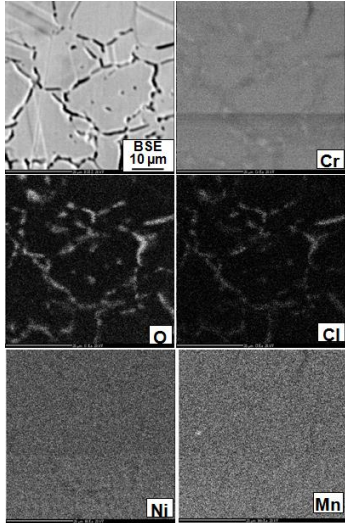
BSE micrograph close to the fracture obtained in un-etched condition exhibits continuous thin film along grain boundaries (Figure 3). This observation is analogue to the optical microstructure (Figure 2). The X-ray elemental mappings of Cr, O, Cl, Ni and Mn elements of failed wire rope in un-etched condition obtained by EPMA are shown in Figure 4. Elemental distribution mapping reveals that the grain boundaries are enriched with Oxygen, Chlorine and Chromium. On the other hand, uniform distributions of Nickel and Manganese are observed in the matrix.

Fig. 4. X-ray elemental distribution mappings of Cr, O, Cl Ni and Mn obtained by EPMA illustrates enrichment of Cr, Cl and O along the grain boundary.

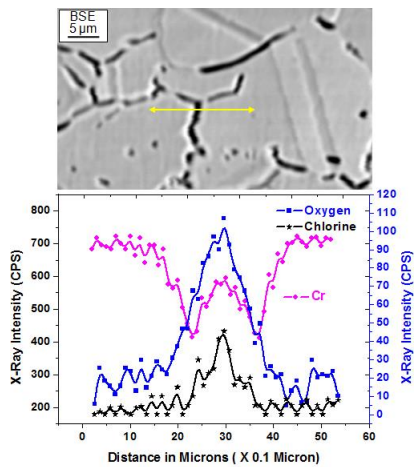
In order to confirm the results of elemental mapping, X-ray line scan technique has been employed for Oxygen Chlorine and Chromium elements and results are shown in Figure 5. This reflects evidently that the line scan profiles have validated the enrichment of Oxygen, and Chlorine at the grain boundary. Line profile has also displayed the chromium enrichment at the grain boundary as well as the depletion at either side of the grain (i.e. vicinity of grain boundary). The weakening of grain boundaries along with dislodged materials from the periphery of the wire therefore indicates that the rope is exposed to corrosive environment during the service. Presence of Cl and O at the grain boundaries in the form of thin film supports the same.

content / vapours from humid atmosphere have initially reacted with chromium oxide passive film formed on the surface of the wire and then diffused within the material along the grain boundaries. The depletion of the Cr in vicinity of the grain boundaries supports the same (Figure 5). This has resulted in the failure of the wire rope in intergranular mode due to substantial weakening of grain boundaries.

Fig. 5. EPMA Line profile of the elements O, Cl and Cr across the grain boundary demonstrates as reflected in the X-ray mappings.

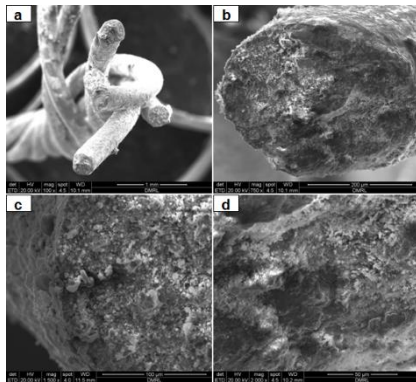
The fracture surfaces of failed wire rope near the actual fractures are shown in Figure 6 (a-d). Thick layer of foreign material deposition is exhibited over the fracture surface of the individual wires and also all around the surface of each wire. In fact fracture surfaces of the failed rope have shown the presence of corrosion debris which has masked the actual fracture (Figure 6). The fracture surfaces of the wire appear to be rough and the individual

wire does not show distinctive mode of fracture features. These are similar to mud cracks with oxide layer (Figure 6b-d). The Energy Dispersive Spectroscopy (EDS) spectrum taken on fracture surface of the failed rope near the actual fractures has revealed the presence of chlorine and oxygen in addition to matrix elements (Figure 7). These results are well agreement with those obtained by EPMA analysis (Figure 4 and 5). All the wires in the failed rope have shown similar behaviour.

Fig. 6. SEM fractographs of individual failed wire obtained at (a) Low magnification and (b-d) high magnification show thick layer deposition of corrosion debris over the fracture surface.

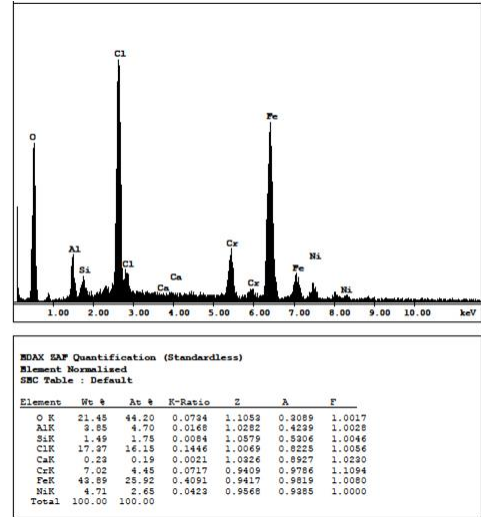
Fig. 7. EDS Spectrum taken from the fracture surface of the failed individual wire exhibits presence of O and Cl in addition to matrix elements.

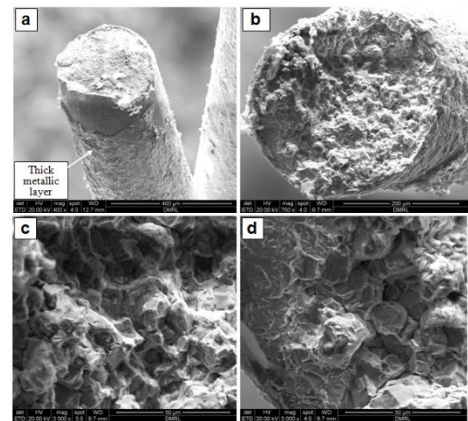
The results of the tensile tests of the failed and unused wires have been utilized to explain the occurrence of typical fracture features of the failed wire rope. The fracture surfaces of tensile tested specimens of the failed and unused wires are shown in Figure 8 and 9. The flat fracture with no reduction in the cross sectional area is seen in the failed individual wire (Figure 8a). The fracture surface of the wire appears to be rough and clearly reveal the presence of intergranular fracture (Figure 8c-d). The failed wire clearly shows typical brittle fracture in spite of the presence of corrosive debris. Fracture surface of tensile tested wire of the failed rope displayed a thick metallic layer covered around the circumference of the failed wire.

However, a part of the thick layer of the individual wire has fallen away from close to tensile fracture during tensile deformation (Figure 8a).

Unused wire rope has undergone significant necking before tensile failure and finally failed in ductile mode. This clearly suggests that the failed wire rope has slowly deteriorated during service and then suddenly failed with intergranular fracture mode. It appears that the crack propagated along the weak grain boundaries and finally failed in brittle mode of fracture (Figure 8).

Fig. 8. SEM fractographs of tensile tested failed wire rope: (a) low magnification and (b-d) High magnification reveals flat fracture with intergranular mode of failure.
