## Microstructural analysis of cracked steam drum plate during fabrication process

The present work then focused on the metallurgical failure analysis of a 123-mm thick steel plate which was cracked during the fabrication. The visual inspection and microstructural investigation were conducted to obtain the

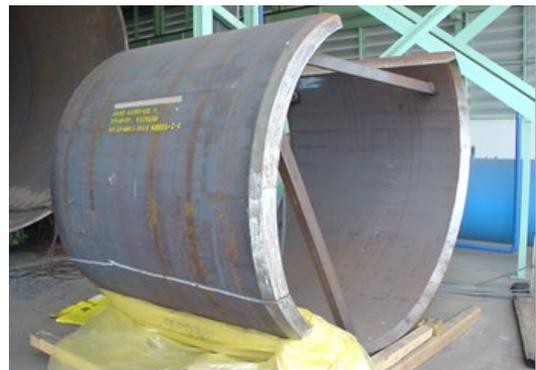
This investigation was conducted on a 123-mm thick steel plate which was fractured during the rolling process of the steam drum fabrication. The cracked steel plate in as-received condition is shown in Figure 1.

Figure 1. Fractured steel plate in as-received condition.

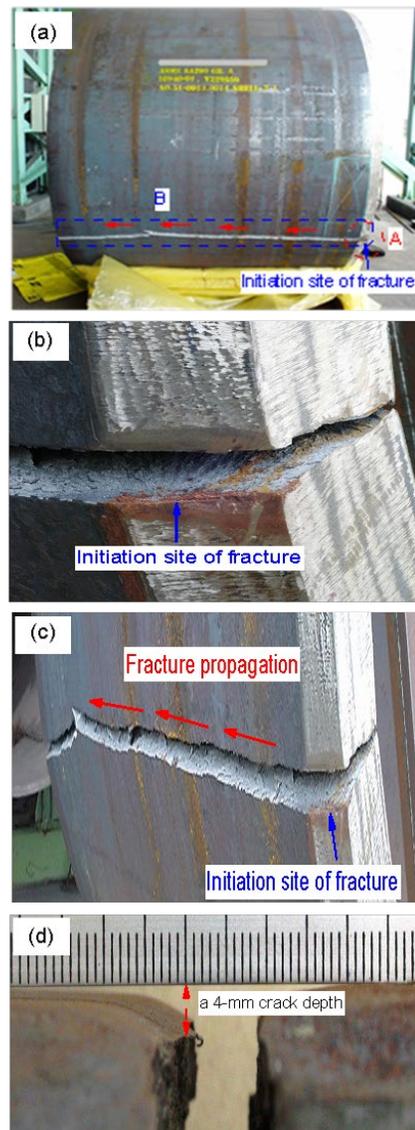
Figure 2 (a) shows the as-received fractured steel plate. It is obvious that the fracture initiated and propagated in the longitudinal direction of the rolled plate, as indicated by “B” and red arrows. The result from examination displayed no gross deformation, necking and thinning of the plate adjacent to the fracture, meaning that the steel plate underwent brittle fracture during the rolling process. It is evident that the edge of the failed steel plate was beveled by the gas cutting process, which was prepared for the circumferential weld joint. It is also

As indicated by A in Figure 2(a), the fracture initiation site was observed between the rolling marks, and it obviously appeared on the outer surface of the slope transition prepared for joining with the thinner steel plate. The enlarged view of the initiation site of this fracture in Figure 2(a) was shown in Figure 2(b). As pointed by the arrow, the fracture origin site was observed. The notch was found along the edge of the lower surface. Figure 2(c) exhibited the fracture propagation which obviously proceeded from the fracture initiation direction in the longitudinal axis perpendicular to the rolling direction.

Figure 2. (a) The as-received fractured steel plate, showing fracture initiation site (A) and the propagation direction (B and red arrows), (b) the enlarged view of the fracture initiation site, (c) the fracture propagation and (d) the depth of the crack.

Figure 2 (d) provided the details of the notch depth, which was estimated to be 4 mm. The fracture surface of the failed steel plate was shown in Figure 3 (a).

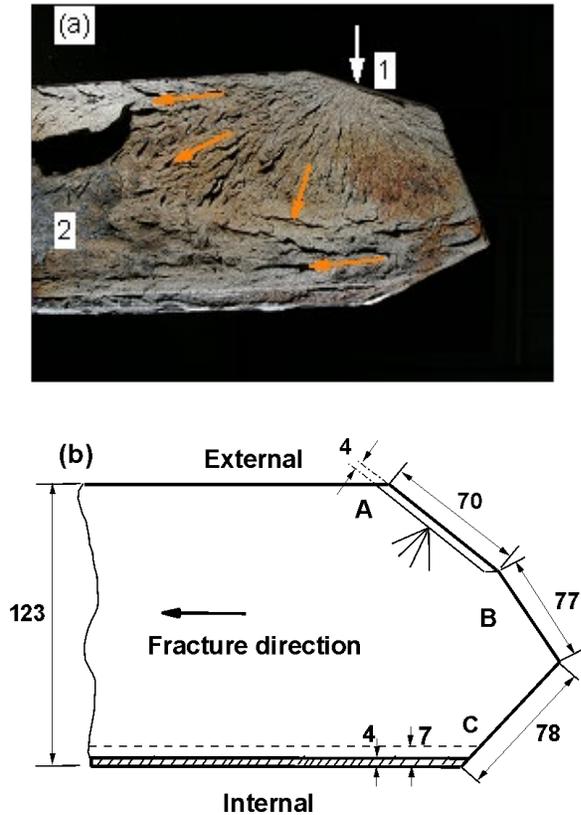
Figure 3. (a) The fracture surface and (b) the sketch of the fracture surface with the dimension on the beveled surface.

The observation on the fracture surface from Figure 3(a) provided the location of the crack origin taking place on the outer beveled surface. The chevron patterns as the distinguishing marks of the brittle fracture were clearly seen (Sowards et al., 2012; Li et al., 2013). Technically, these marks can indicate the crack propagation direction. The apex of these marks normally points toward the crack origin (Hazra & Singh, 2021; Rao & Eischen, 2016). Thus, the fracture should be originated from Area 1 and propagated toward Area 2, as given by the arrow in Figure 3(a). To clearly understand the fracture, the sketch of the fracture surface with dimensions on the beveled surface was given in Figure 3(b). The shaded area indicates the 4-mm width shear lip after fracture and the dash line means the 7-mm width unfractured area.

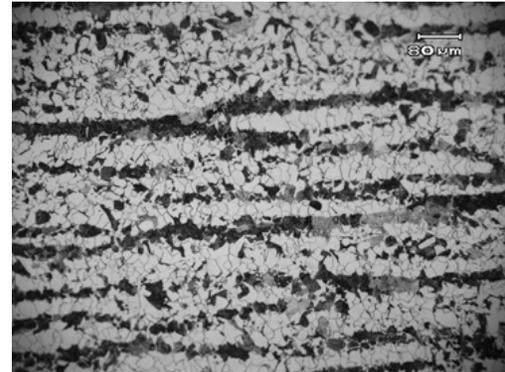
Figure 4. Microstructure examination conducted at the mid-wall of the failed steel plate.

Microstructure examination at the mid-wall of the failed plate clearly exhibited the ferrite/pearlite banded structure. This kind of structure is usually found in the hot rolled steels and it can be described as a microstructure which composes of alternate layers of pro-eutectoid ferrite and pearlite in comparison to irregular distribution of these microstructural constituents (Peeratatsuwan & Chowwanonthapunya, 2020).

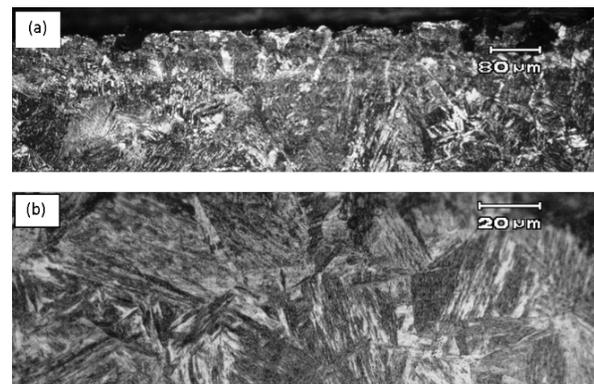
The microstructure of the edge “A” investigated from the external surface to the mid-wall plate was shown in Figure 5(a)-(b) and the microstructure transformation was obviously observed, indicating that these areas were heat-affected from the gas cutting process. Technically, the gas cutting process provides the preheat flame, which can raise the edge of the steel plate to about 980°C so that the steel at the edge can be oxidized and then blown away (Adedayo, 2011).

Figure 5. (a) Microstructure alternation found from the edge “A” of Figure 3(b) and (b) the higher magnification of the altered microstructure taken at the edge “A.”

Obviously, the preheat temperature is above the transformation temperature, resulting in the transformation of ferrite/pearlite into austenite. After cutting, the steel plate is subjected to the natural cooling process, the cooling rate of which determines the final microstructure. The near surface region of the edge “A” was directly affected from the heat of the thermal gas cutting process and after the cutting process, this area underwent the rapid cooling rate because it directly contacted with the cold air, the temperature of which was just slightly above 0°C. The 123-mm thick steel plate, considered as a thick plate, also facilitated the faster heat dissipation by heat conduction. Thus, the final microstructure of this region after cooling was mostly related to the formation of martensite, as depicted in Figure 5(a)-(b). The finding in this section pointed out that heat generated from the gas cutting process facilitated the transformation of austenite and the rapid cooling at the metal/air interface was responsible for the martensite formation, which is hard and brittle in nature. The presence of such brittle phase promoted the brittleness and resulted in the residual stress accumulation (Barbosa et al., 2006). Both can reduce the crack resistance in the near surface region of the edge “A,” which would potentially lead to the premature fracture of the failed steel plate.

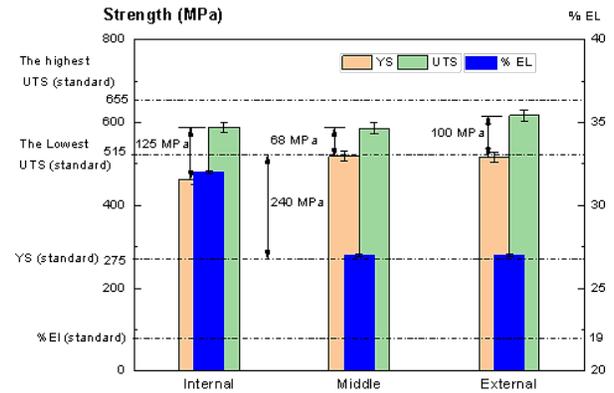
To obtain useful information about the fabrication of this steel plate, a tensile test and Charpy impact test were conducted. Tensile test was conducted according to ASTM A370-21 (ASTM A370-21, 2021). and round specimens for tensile test were prepared from the inner, the mid-wall, and external part of unaffected areas of the failed steel plate. Their diameter was 12.5 +/- 0.2 mm and gauge length were 50 +/- 0.1 mm. The averaged properties obtained from tensile test and the standard values of properties were given in Figure 6. Results of testing revealed that the steel plate has complied with the standard requirement of mechanical properties. However, the yield strength value of all tensile test specimens was significantly higher than that specified in the standard requirement.

Technically, steel can be hardened when it is subjected to the mechanical forming process (Krishna et al., 2015). This steel plate was pre-bended and rolled for the fabrication of the steam drum. Hence, the increased yield strength would be resulted from the pre-bending and rolling process. The lowered difference between the ultimate tensile and yield strength can be seen from Figure 6. As indicated in this figure, the lowest difference value of the ultimate tensile and yield strength was 68 MPa, but that of the lowest ultimate tensile and yield strength in standard was 240 MPa. This finding means that as crack initiated after yielding, it required just slightly more applied stress to propagate in the transverse direction perpendicular to the rolling direction of the steel

Figure 6. Yield strength (YS), ultimate tensile strength (UTS), and % Elongation (%EL) obtained from tensile test.

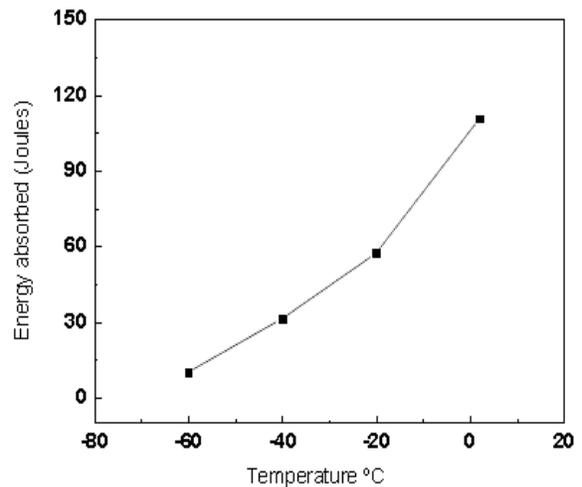
Figure 7. Absorbed energy from the impact test.

Figure 7 showed the results of Charpy V-notch test conducted on specimens prepared from the failed steel plate (unaffected area). It was clearly seen that the absorbed energy showed acceptable results for a pressure vessel used in operation with the temperature from 0 to -40 °C. However, as temperature became lower, the absorbed energy of specimens significantly decreased. Thus, this finding may suggest that the thick steel plate should be warmed up to

significantly above 0°C so that the absorbed energy of steel can be recovered, and the better fracture toughness of steel can be obtained, particularly when it the steel plate encounters the forming stress in the plain strain condition.

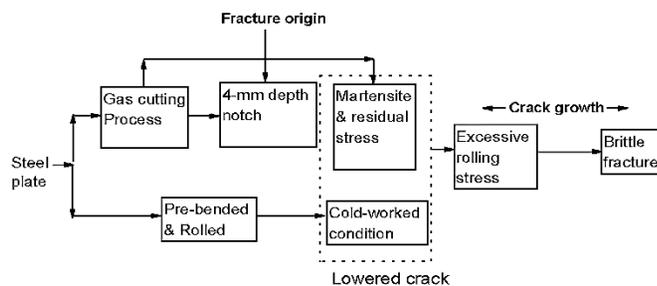
The schematics diagram used to explain the failure mechanisms of the failed steel plate is provided in Figure 8. SA 299 carbon steel plate was prepared for the steam drum fabrication. The edge of the plate was subjected to the gas cutting process for the weld joint preparation. The thermal gas cutting caused not only the formation of a 4-mm depth notch but also the microstructure change. The edge "A" from Figure 3(b) underwent the transformation of ferrite-pearlite into austenite during heating and the rapid cooling at the edge "A" and the cold air facilitated the formation of martensite, as clearly seen from. Besides, the residual stress in the steel may also be accumulated in the steel.

Figure 8. The schematic diagram illustrates the mechanisms of failure occurring in the failed steel plate.

The rolling process can produce cold-worked conditions to the steel plate. All potentially reduced the crack resistance of the steel plate. During fabrication, steel plate experienced rolling stress, which was excessive. The notch would function as the stress concentration and then became the crack origin. The excessive forming stress accelerated the crack propagation through the degraded crack resistance steel plate, finally causing the brittle fracture as clearly observed from Figure 2 and 3. Based on the results of this investigation, the recommendations, it is advised to remove the notch by grinding. Grinding the notch removed not only the stress concentration effect but also the heat affected area. The results from the Charpy impact test provided the fact that warming up the steel plate to be markedly above 0°C is useful to improve the toughness of the steel plate.
