## Micro-structural analysis and elastic properties of oil palm trunk fibre reinforced polyester composites

Anthony N. Anyakora <sup>a,\*</sup>, Oladiran K. Abubakre <sup>b</sup>

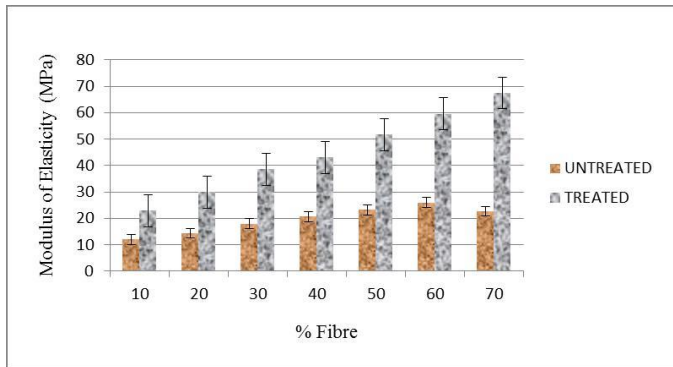
Fig. 1. MOE of untreated and treated oil palm trunk fibre reinforced polyester composites.

The MOE properties of the composites were measured and the results are represented in Figure 1.

It was observed that the treated oil palm trunk treated composites exhibited outstanding MOE values showing the positive effect of surface treatment for achieving improved elastic properties. Although there was remarkable and continuous increment in the MOE of treated oil palm trunk fibre composites, the trend was similar to the values of MOE for untreated composites till 60wt. % fibre content before subsequent drop. This was different from the findings of Keramat, Jahromi, Jafari, Mohtasebi, and Rafiee, (2008) - which the modulus of elasticity increased with increasing fibre content. This could be ascribed to fabrication defect and the unstable morphology of oil palm fibre.

Other corroborated findings include the consideration of large amounts of lignin contained in oil palm fibres, with very porous and lacuna-like cross-section of varying diameters, that affect their mechanical properties, such as high ductility, but have lower tensile strength than most other natural plant fibres reported by Sreekala et al., (1997), including the moduli of elasticity of treated fibre reinforced plastics generally improving with increased fibre content in the composite.

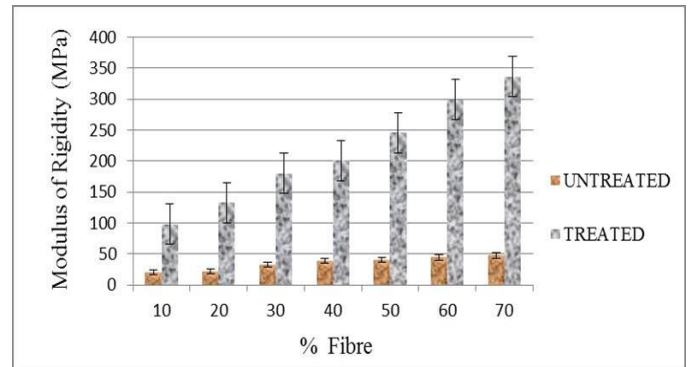
Fig. 2. MOR of untreated and treated oil palm trunk fibre reinforced polyester composites.

The MOR properties of the composites were measured and the results are represented in Figure 2.

From the results shown in Figure 2, it was obvious of very outstanding values of Modulus of Rigidity even higher than observed in the MOE. Surprisingly, there was no drop in MOR after 60wt. % fibre content as in the MOE results. It was obvious that the issue of unstable morphology of oil palm trunk fibre superseded the suggested fabrication defect.

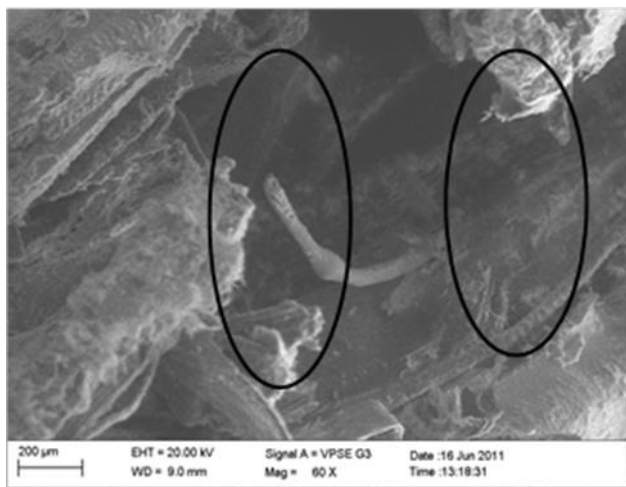
Fig. 3. SEM micrograph of untreated oil palm trunk fibre reinforced polyester composite showing fibre peeling and pull out at 70wt. % fibre content.

The SEM analyses of fractured surfaces after tensile loading of the composites are represented in Figures 3 and 4.

From the scanned electron microscopy, an indication of uneven mixing of the fibre surfaces with protrusions and small voids were observed in both the untreated and

fractured treated natural fibre composites showed that the composites failed by a combination of fibre fracture and fibre pull-out indicating that fibre fracture was a major mechanism in the strength of composite. The results of the

fractured surfaces showed that the reinforcing fibres were damaged during stress loading suggesting that the mechanism of fracture was dependent on the fibre type, fibre strength and void content of the sample.

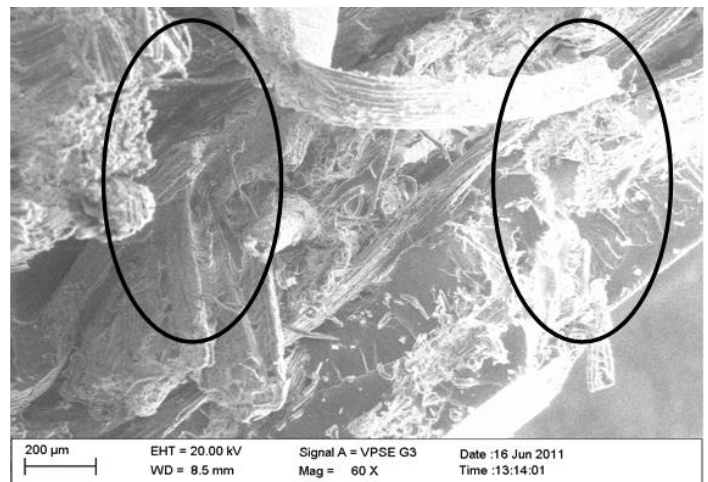
Fig. 4. SEM micrograph of treated oil palm trunk fibre reinforced polyester composite showing the tensile fractured surfaces at 70wt. % fibre content.
